# Manhole Inspection Summary

Manhole # S43A\_\_043MH

Insp Date: **7/18/08 10:25 AM**

**Location** Address: **1501 jefferson st**

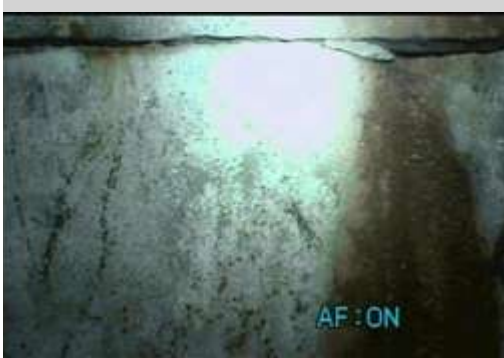
Defect 3

Infiltration: ☐ None ☒ **Joint** ☐ Cracks ☐ Mortar ☐ Roots ☐ Wall

barrel joint infiltration

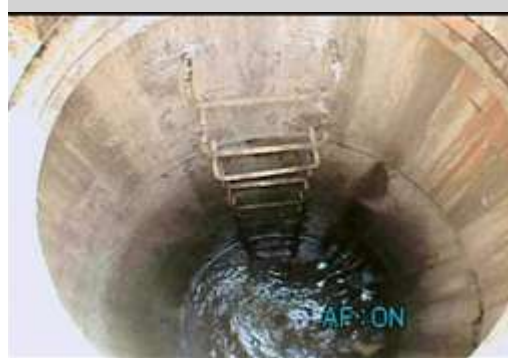
Defect 2

**Steps** Count: **9** Missing: **0** ☒ **Corroded**

corroded steps

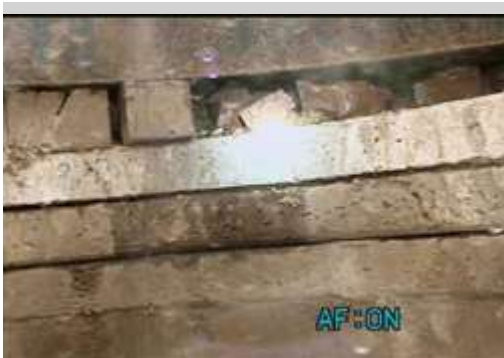
Defect 1

Condition: ☐ Sound ☒ **Cracked** ☐ Root Intrusion ☒ **Loose Brick** ☐ Deteriorated

cracked, loose bricks chimney frame adj

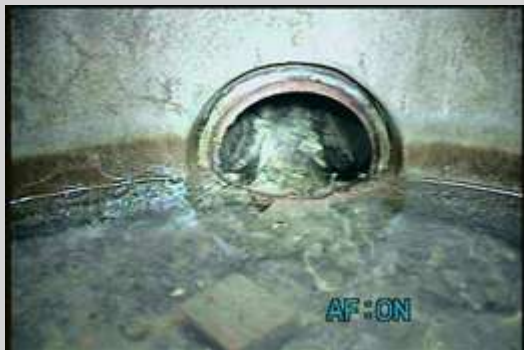
12 O'Clock Outflow

8 in. Circular Gravity Sewer  
Pipe Out @ 12 O'Clock

Pipe Material: **Clay** ☐ Pipe Lined

Invert Depth: 11.30 (ft.) Flow Characteristics: **Fast**

Infiltration: **None** Pipe Seal Cond: **Unknown**

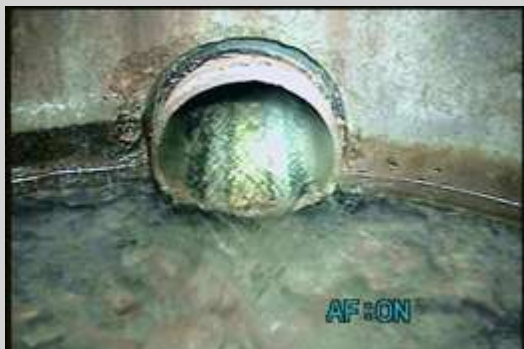
9 O'Clock Inflow

8 in. Circular Gravity Sewer  
Pipe In @ 9 O'Clock

Pipe Material: **Clay** ☐ Pipe Lined

Invert Depth: 11.20 (ft.) Flow Characteristics: **Fast**

Infiltration: **None** Pipe Seal Cond: **Unknown**
